DEPARTMENT OF TRANSPORTATION

Contract #: 04-0120F4Cty: SF/ALA Rte: 80 PM: 13.2/13.9File #: 99.28**WELDING INSPECTION REPORT****Resident Engineer:**Siegenthaler, Peter**Address:** 333 Burma Road**City:** Oakland, CA 94607**Report No:** WIR-022793**Date Inspected:** 23-Apr-2011**Project Name:** SAS Superstructure**OSM Arrival Time:** 700**Prime Contractor:** American Bridge/Fluor Enterprises, a JV**OSM Departure Time:** 1900**Contractor:** Zhenhua Port Machinery Company, Ltd (ZPMC) Chanxing Island**Location:** Shanghai, China**CWI Name:** Mr. Sun Tian Liang**CWI Present:** Yes No**Inspected CWI report:** Yes No N/A**Rod Oven in Use:** Yes No N/A**Electrode to specification:** Yes No N/A**Weld Procedures Followed:** Yes No N/A**Qualified Welders:** Yes No N/A**Verified Joint Fit-up:** Yes No N/A**Approved Drawings:** Yes No N/A**Approved WPS:** Yes No N/A**Delayed / Cancelled:** Yes No N/A**Bridge No:** 34-0006**Component:** OBG Segment**Summary of Items Observed:**

WELDING INSPECTION REPORT

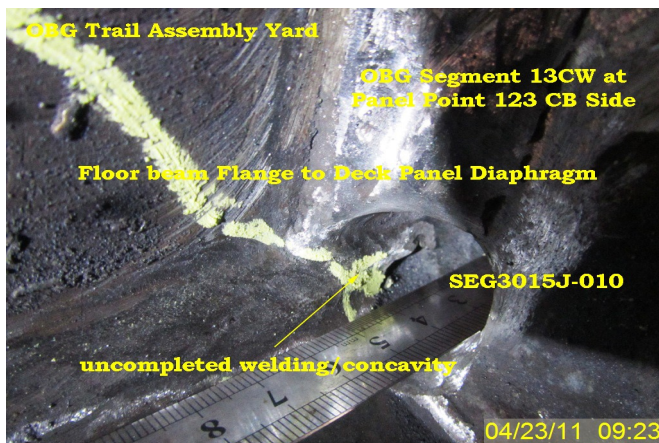
Visual Observation: During random Quality Assurance Visual review of welds located on segment 13CW, this Quality Assurance Inspector (QA) observed that uncompleted welding/concavity measuring approximately 15mm in lengths. The indication is clearly marked on the material near the weld. The weld is identified as SEG3015J-10. The panel point is identified as a PP123. This weld is a Fillet weld joining the Floor beam Flange to Deck Panel Diaphragm at Longitudinal Diaphragm Cope Hole. The Floor Beam Flange weld is identified as Non SPCM. For further information, please see the attached pictures
